**WEST VIRGINIA DEPARTMENT OF ENVIRONMENTAL PROTECTION
WV/NPDES CONSTRUCTION STORMWATER PERMIT**

FACILITY NAME:	BLAKE SOLAR PROJECT			REG. #	WVR111837		EXPIRE DATE:	2/9/2024	
PERMITTEE	HORUS WEST VIRGINIA 1, LLC								
ADDRESS/PHONE:	Attn: Luise Polo Gomez 110 FRONT STREET SUITE 300 Jupiter, Fl 33477 561-277-0300								
LOCATION:	Kabletown Road			Entry Date/Time:	9/26/2023 8:54 9/27/2023 15:20				
COUNTY:	Jefferson			Exit Date/Time:	9/26/2023 11:00 9/27/2023 16:30				
Site Representative /Phone				PHOTOS X					
CO-PERMITTEE:				ADDRESS:					
SITE OPERATOR:				ADDRESS:					
PERMITTED ACREAGE	503	WEATHER:	Cloudy/Rain	LAST INSPECTION:	8/24/2023				
RECEIVING STREAM(S)	Evitts Run						NOV:	W23-19-035-KRA	
Regular Mail	Certified Mail X	Tracking # 9589071052700930690675							
OVERALL FACILITY RATING:	Unsatisfactory		COMPLIANCE OUTCOME	Not Immediately Corrected

PERMIT / SITE EVALUATION

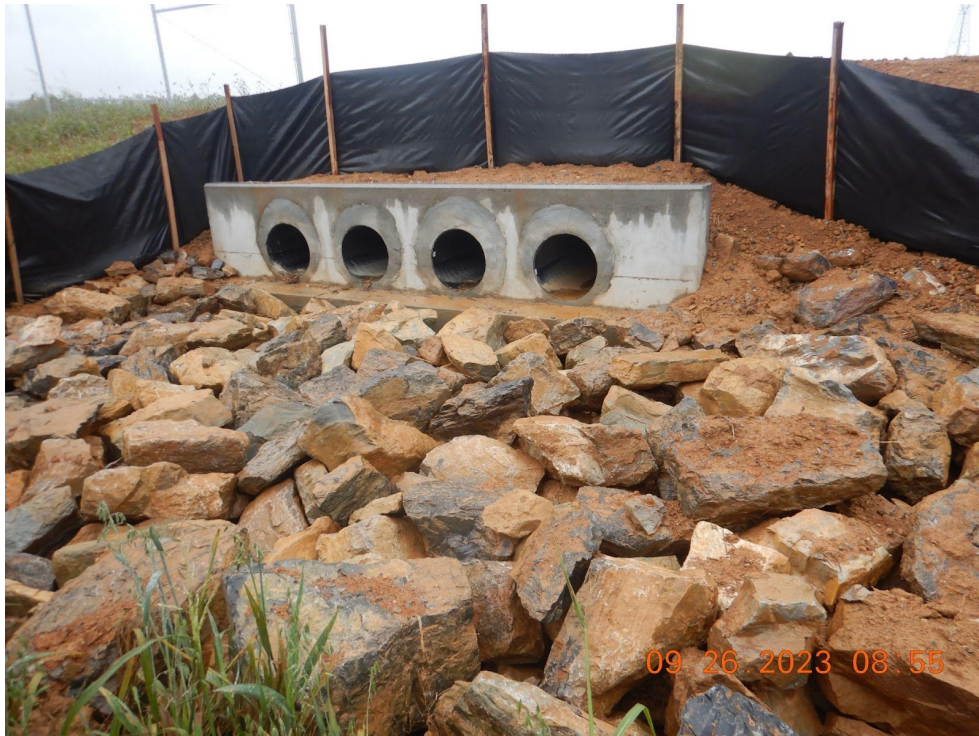
7.) (3,6,13, 19 & 21) Sediment Basin 14 riser has been removed prior to all upstream disturbance being stabilized according to the approved SWPPP. Area above and in the drainage area of Sediment Basin 14 is not vegetated/stabilized. The basin was converted to stormwater management from a sediment trapping structure prematurely contrary to the approved SWPPP. This is causing sediment laden water to run off site into an ephemeral UNT of Evitts Run without going through an appropriate device.

Outlet drainage area of Sediment Basin 14, discharging onto Kabletown Road

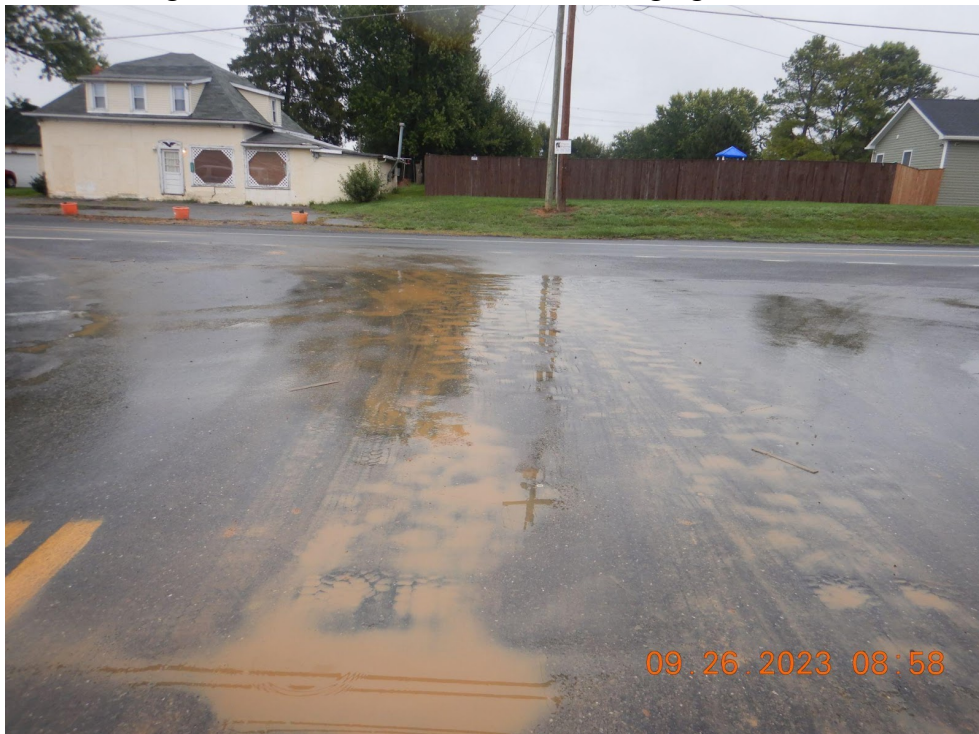
Sediment laden water laying in the road at the intersection of 115 and Kabletown Road.

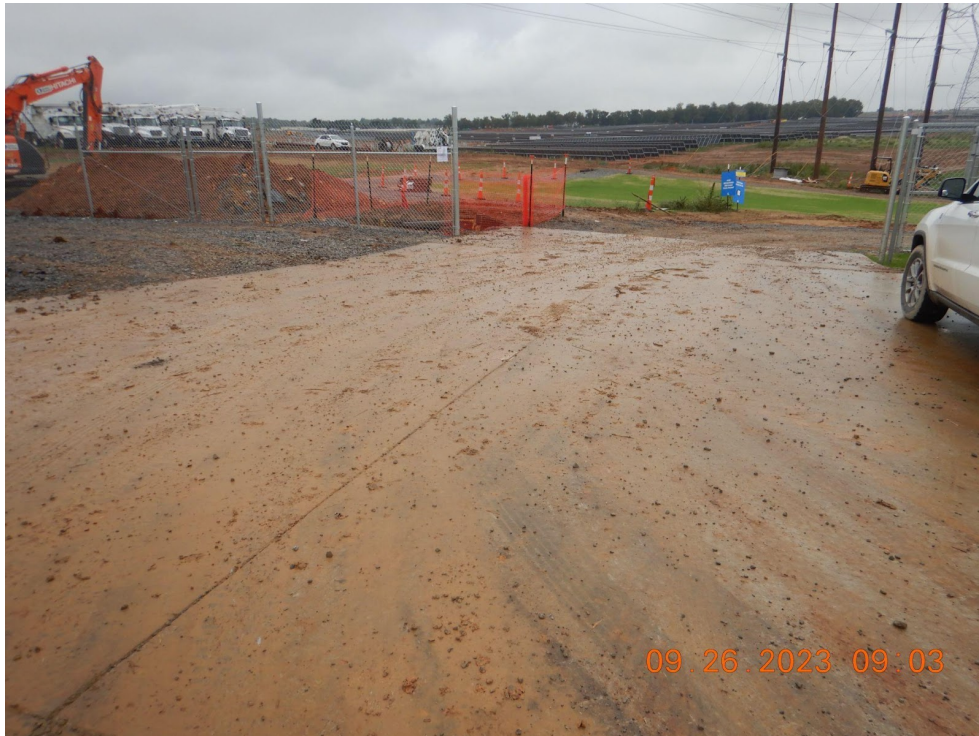
6.) (11,12) Construction entrances need maintenance and stabilization per approved SWPPP. Track out on the public road was not being cleaned up in a timely manner.

Inadequate construction entrance installed to prevent track out from the site.

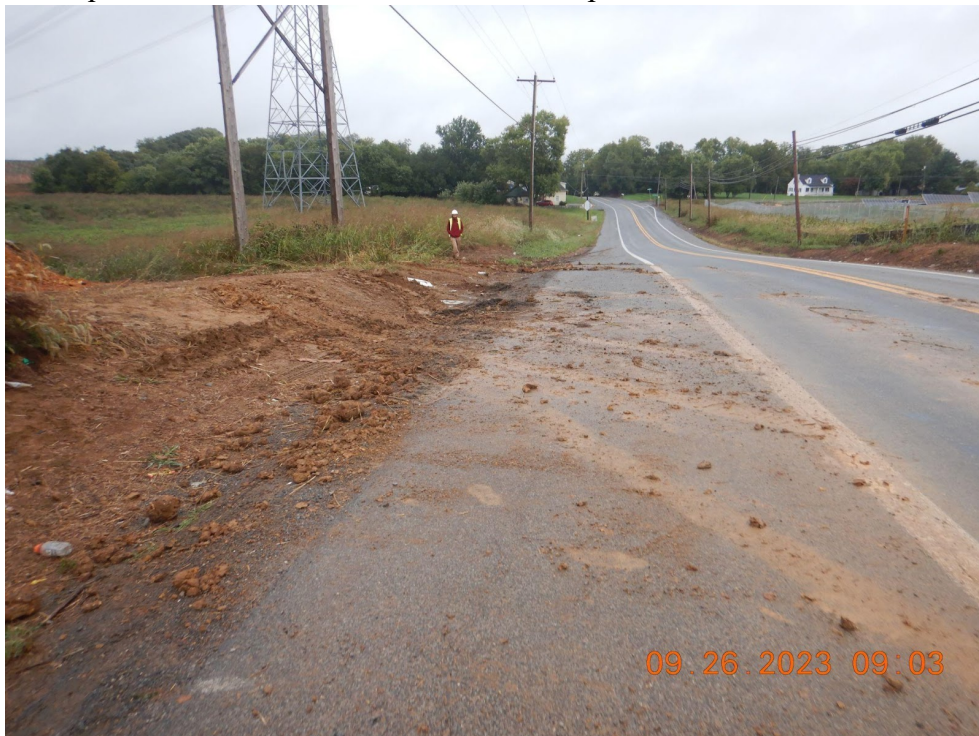
Unstabilized construction entrance.

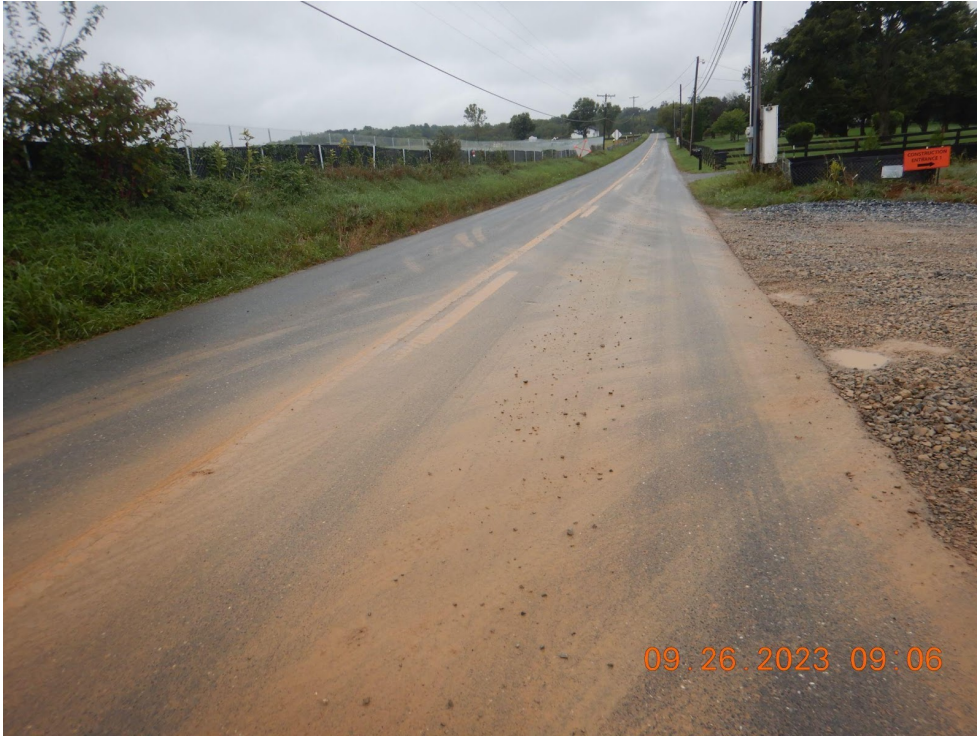
Track out from the site on Kabletown Road.

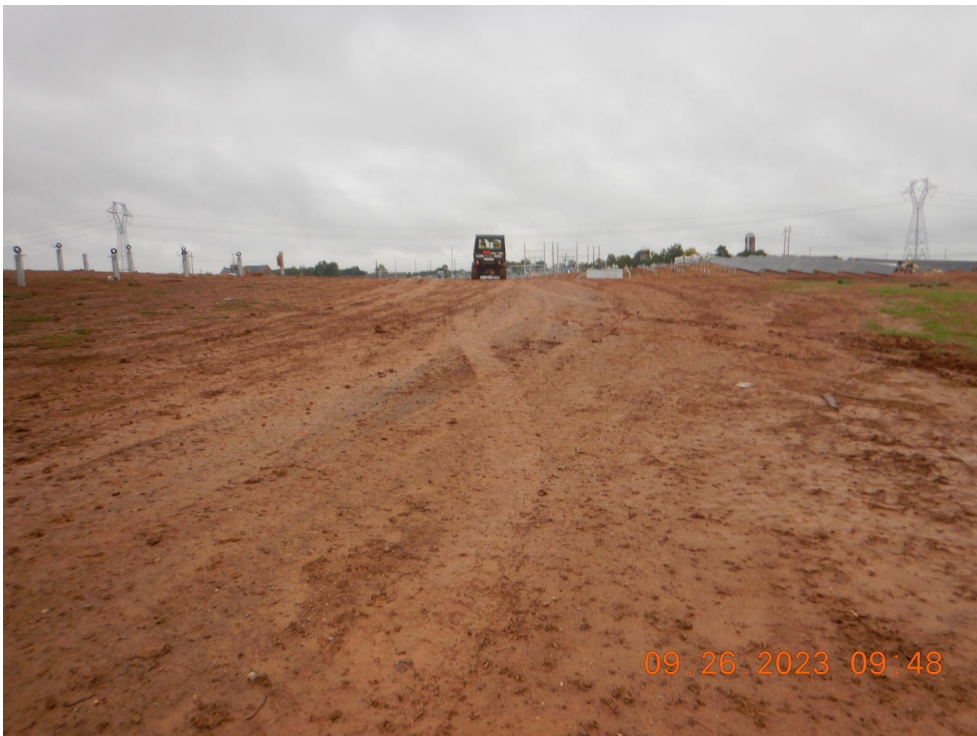
5.) (6,8) Numerous areas through the project area have been idle for greater than 30 days and lack temporary stabilization/permanent stabilization.

Unstabilized area of project. Temporary or permanent stabilization hasn't been started.

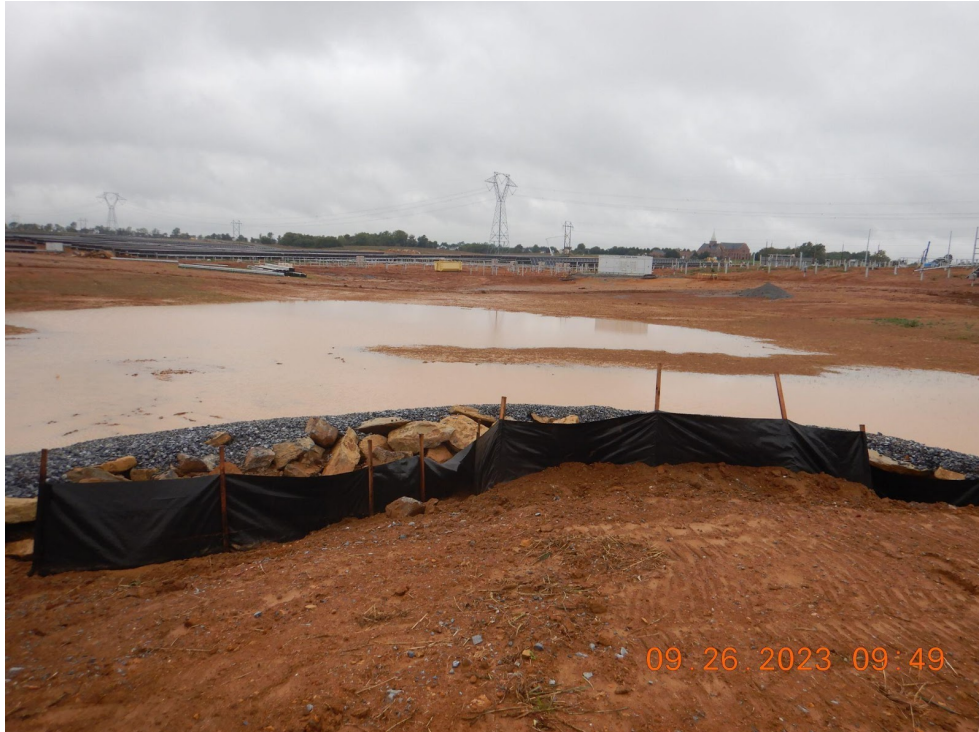
Sediment Pond 14 has been converted to final stormwater management pond prior to all uphill disturbance being vegetated.

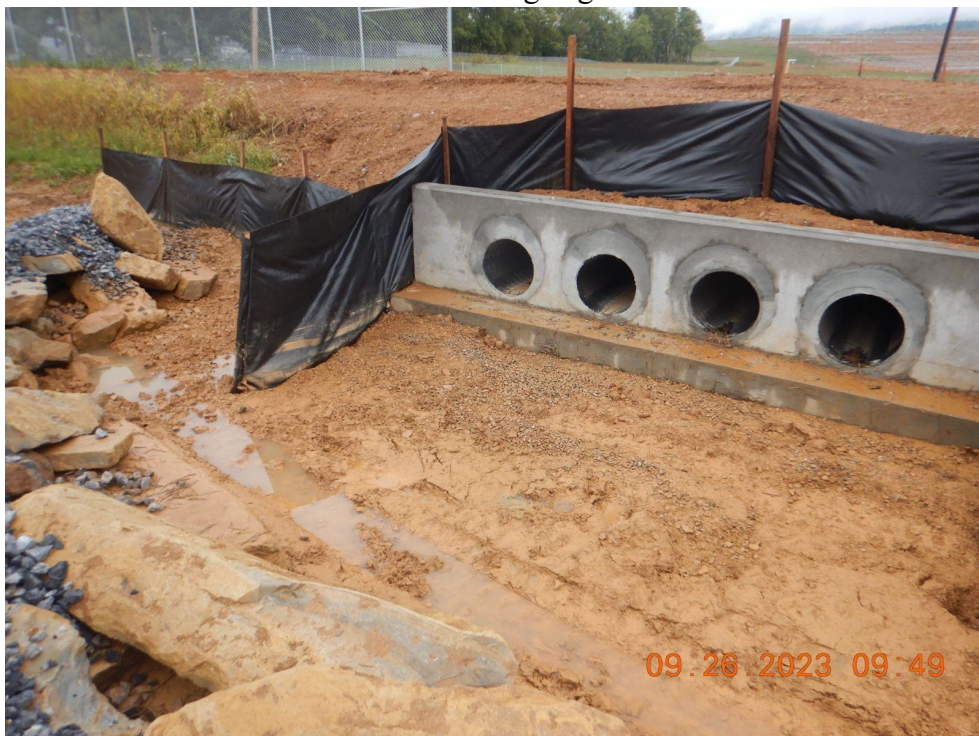
Outlet for stormwater pond 14 has been installed. Sediment laden water leaving site through outlet.

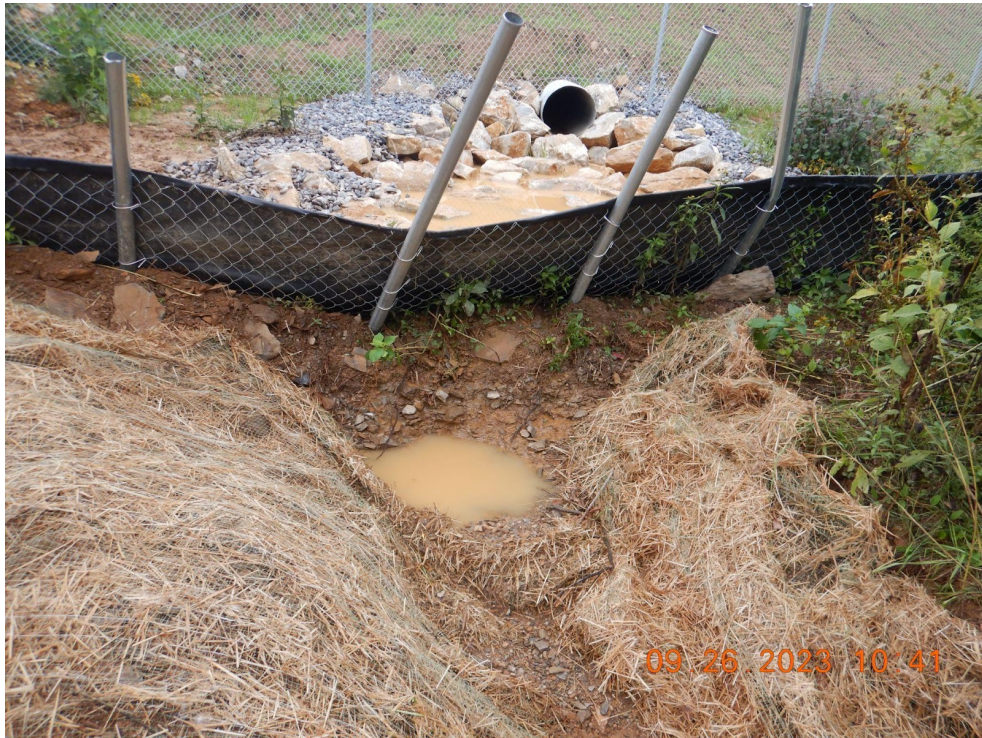
3.) (3, 6, 19 & 20) Sediment basin 6 lacked maintenance at the time of inspection. The basin had accumulated deposits that were greater than 50% of the wet storage capacity and maintenance had not been conducted prior to this inspection. Evidence that sediment laden water had bypassed treatment as a result were observed. Offsite CNA deposits UNT of Evitts Run (39° 15' 33.3189" X -77° 49' 30.6042") were present as a result.

Area of Sediment Basin 6. Sediment Laden water leaving site through outlet. No outlet sign is visible.

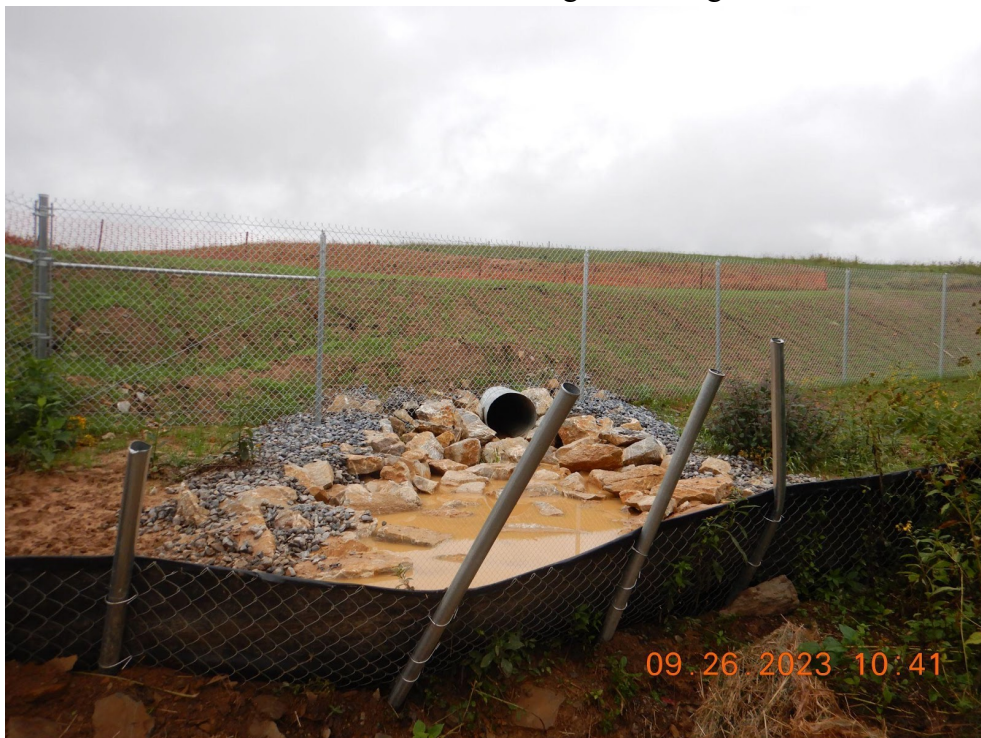
Sediment laden water leaving sediment basin 6. No outlet sign is visible.

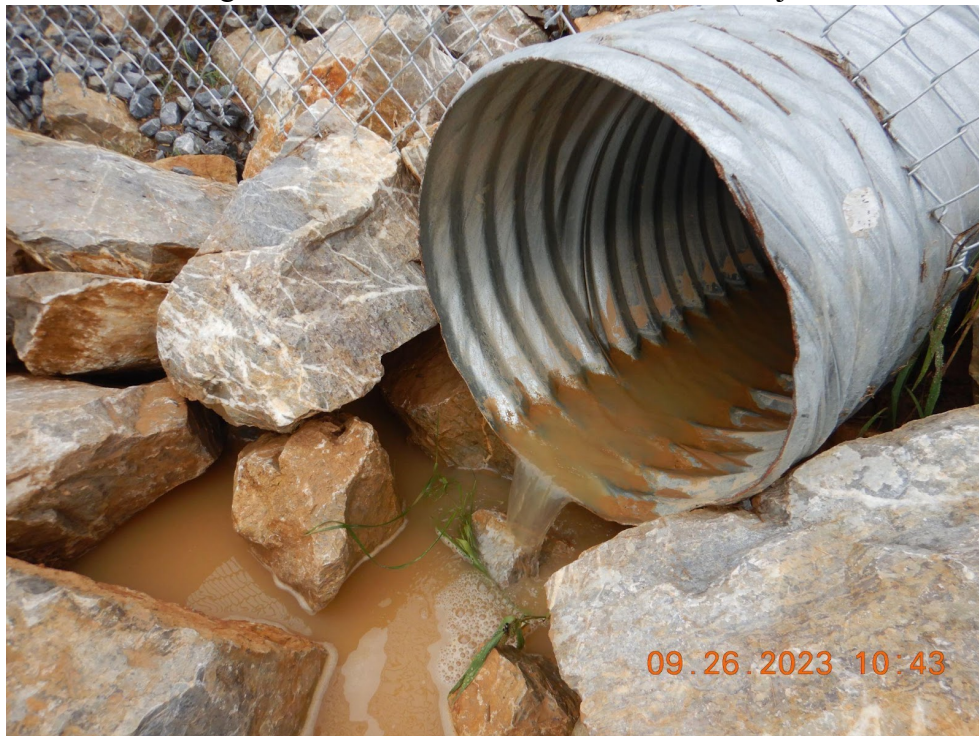
Sediment laden water discharging from Basin 6.

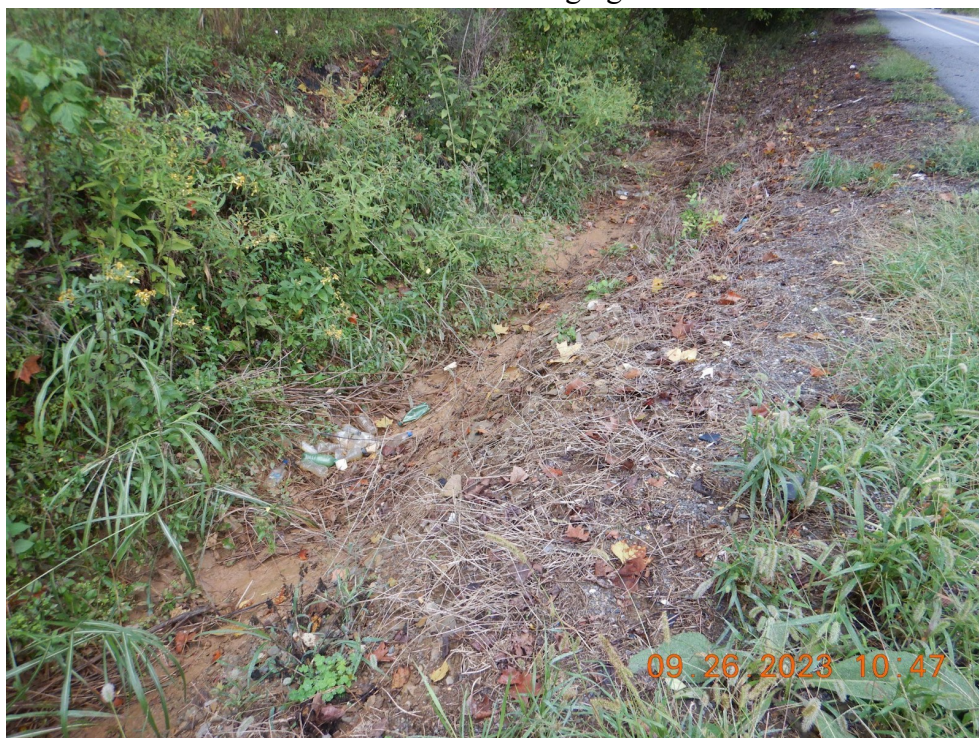
Sediment laden water across road from sediment basin 6 into an Ephemeral UNT of Evitts Run (39° 15' 33.3189" X -77° 49' 30.6042").

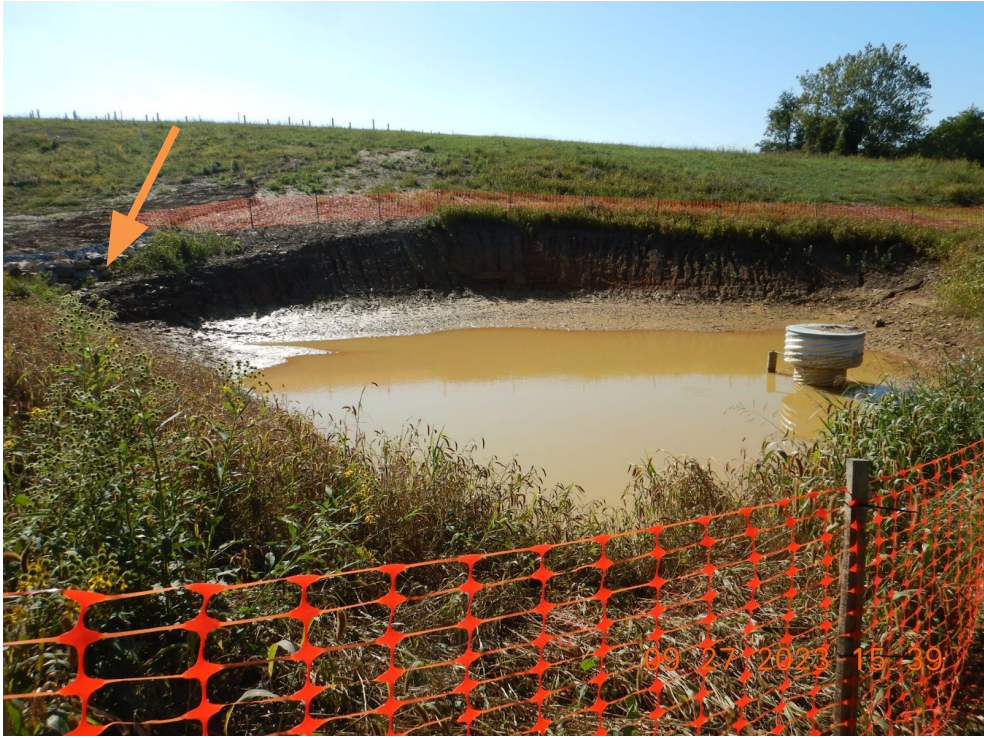
8.) (3) Inlets of Sediment Pond 5 and 6 are not properly armored. Unstable inlets.

Sediment Pond 6 has unstable inlet.

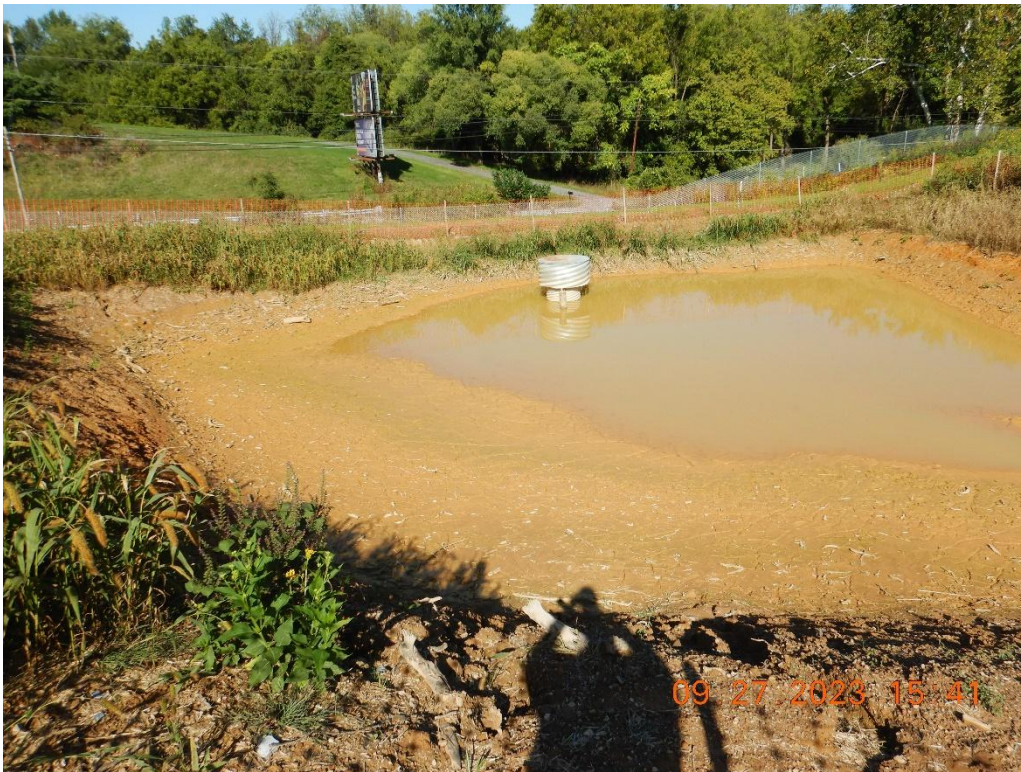
Sediment basin 6 showing the amount of accumulated deposits.

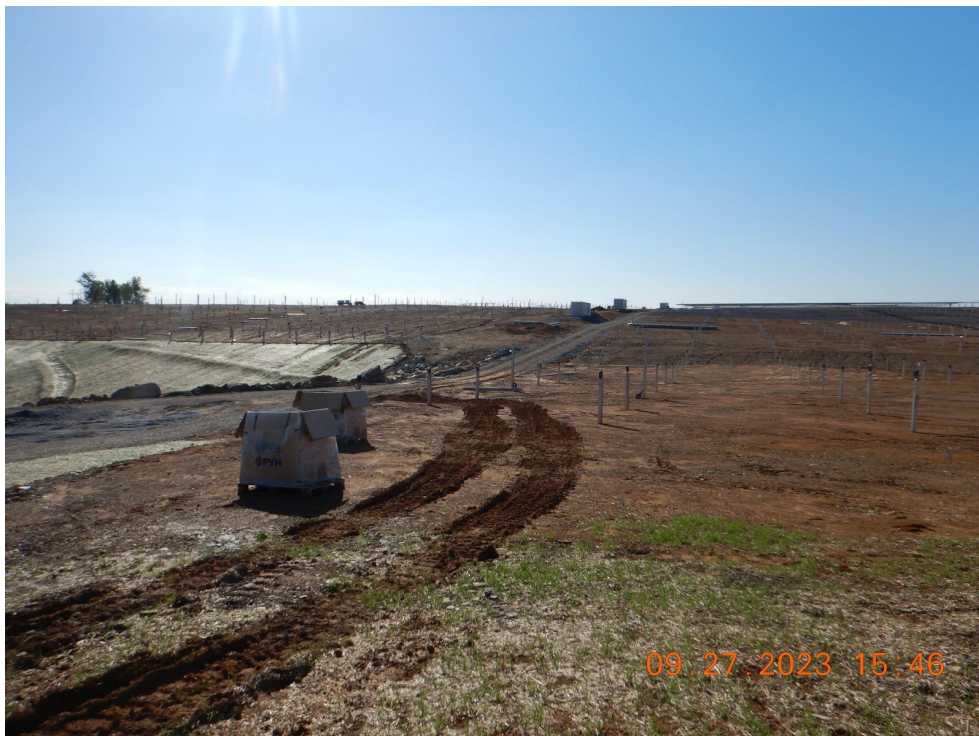
Unstabilized area of project. Temporary or permanent stabilization hasn't been started.

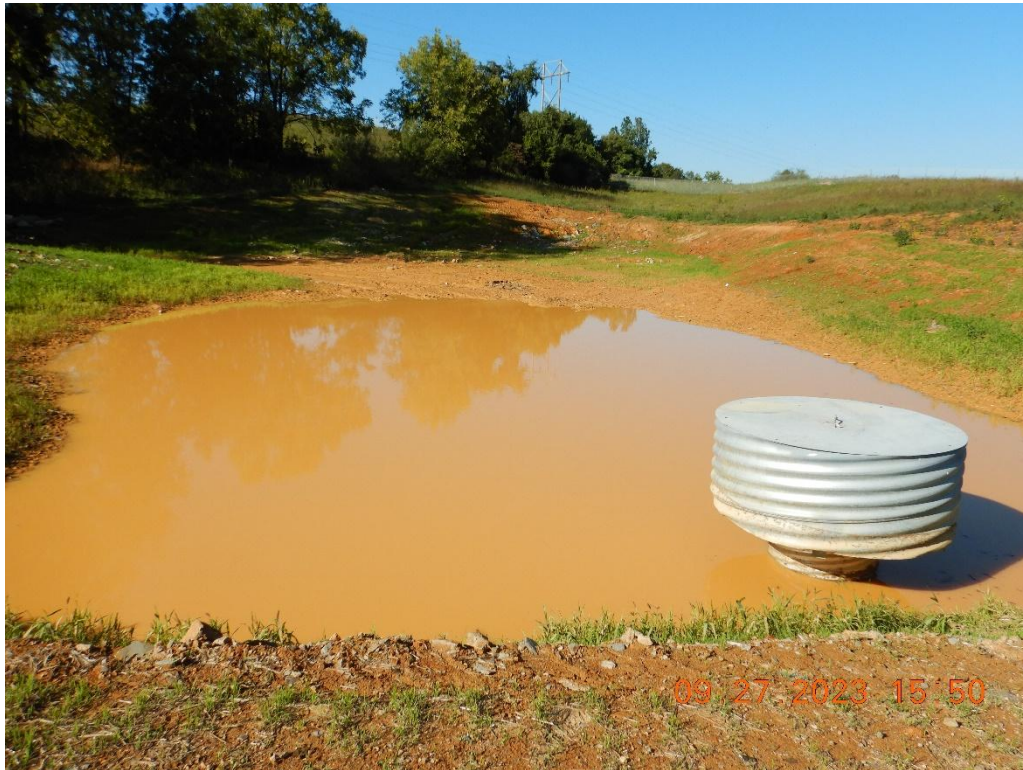
Sediment Pond 5 showing the lack of a stabilized inlet.

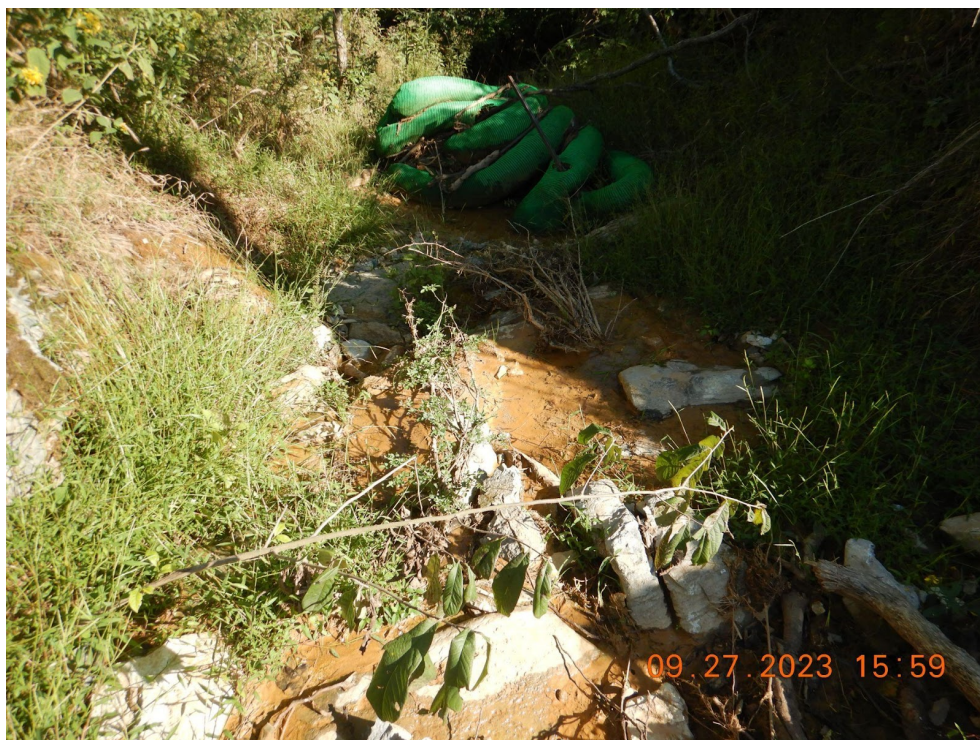
Sediment laden discharge from sediment basin 5 into onsite UNT Evitts Run.

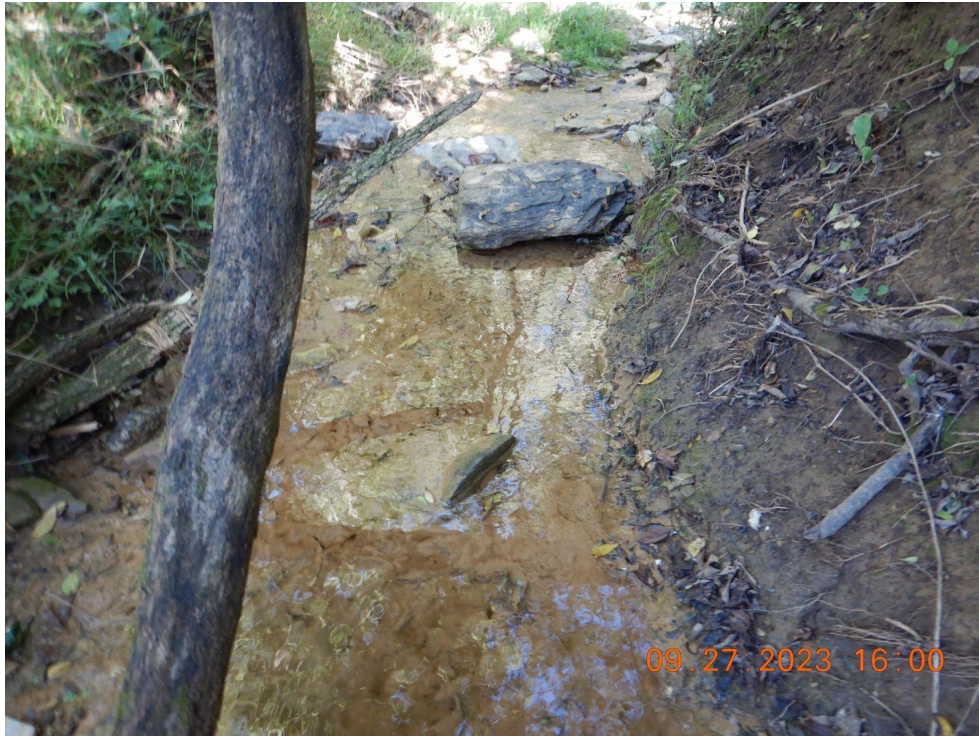
Sediment deposits into onsite UNT Evitts Run from Sediment Basin 5.

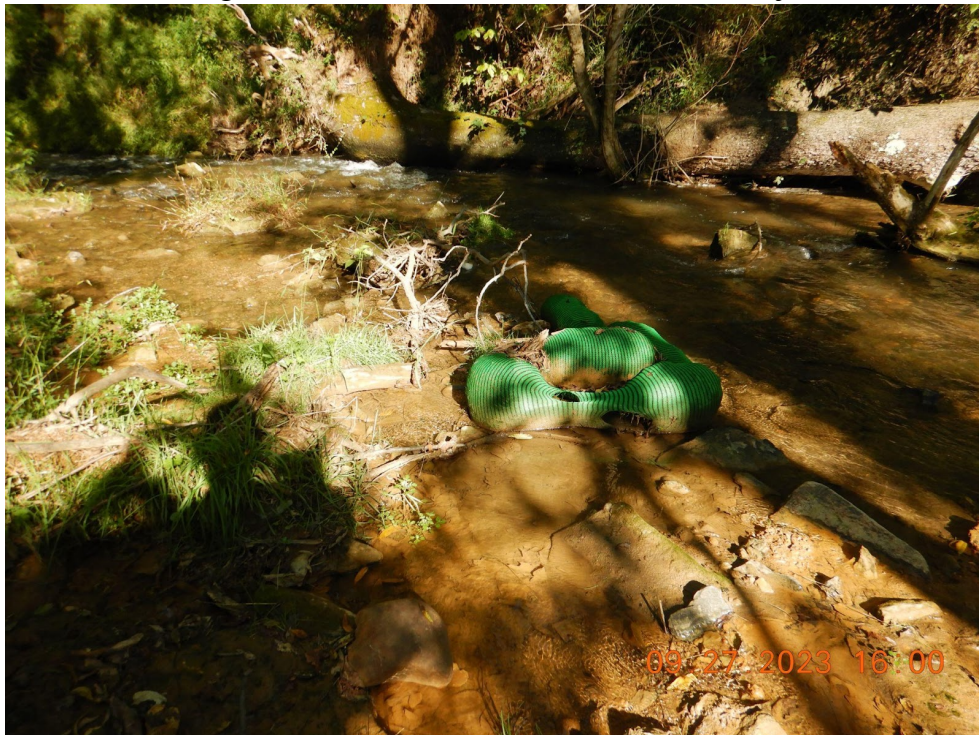
- 1.) (4) No outlet markers on any of the Sediment Traps or Sediment Basins.
- 2.) (3,19, 20 & 21) Evidence that sediment laden water left the site via the outlet of sediment basin 5 due to the trapping structure becoming overwhelmed during a recent rain event was observed. Sediment basin 5, during the high-water event discharged sediment laden water causing offsite Conditions Not Allowable

(CNA) deposits in Evitts Run (39° 15' 17.2288" X -77° 49' 26.9350") from sediment basin 5. The approved SWPPP has proven ineffective in this area.

Conditions not allowable deposits into Evitts Run (39° 15' 17.2288" X -77° 49' 26.9350") from Basin 5.
Filter Sock laying in creek.

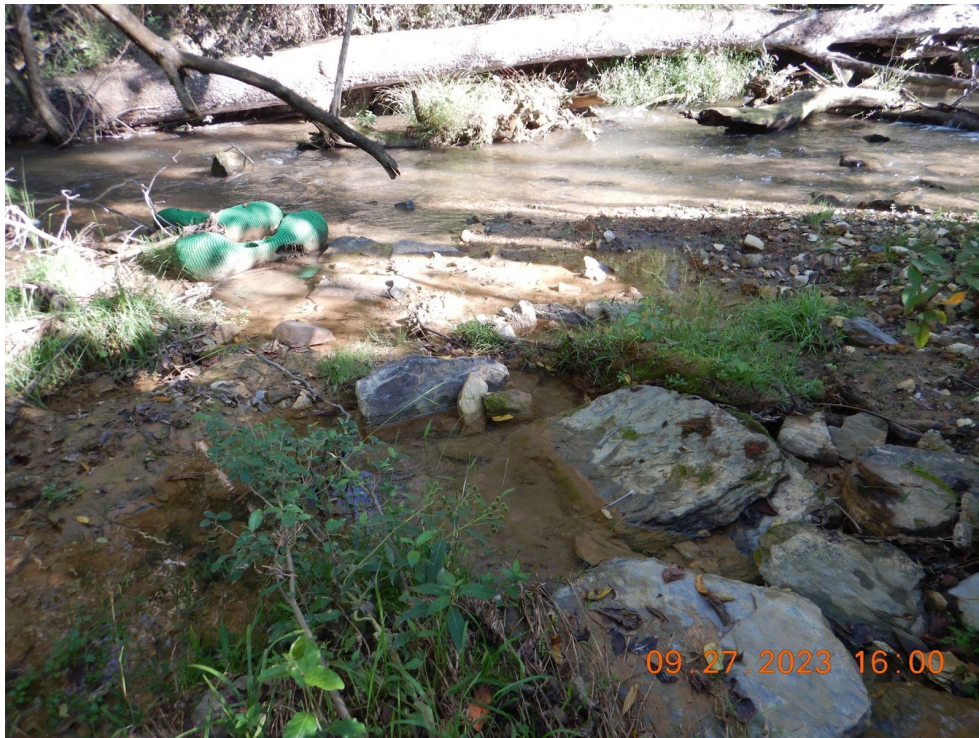
Conditions not allowable deposits into Evitts Run (39° 15' 17.2288" X -77° 49' 26.9350") from Basin 5.

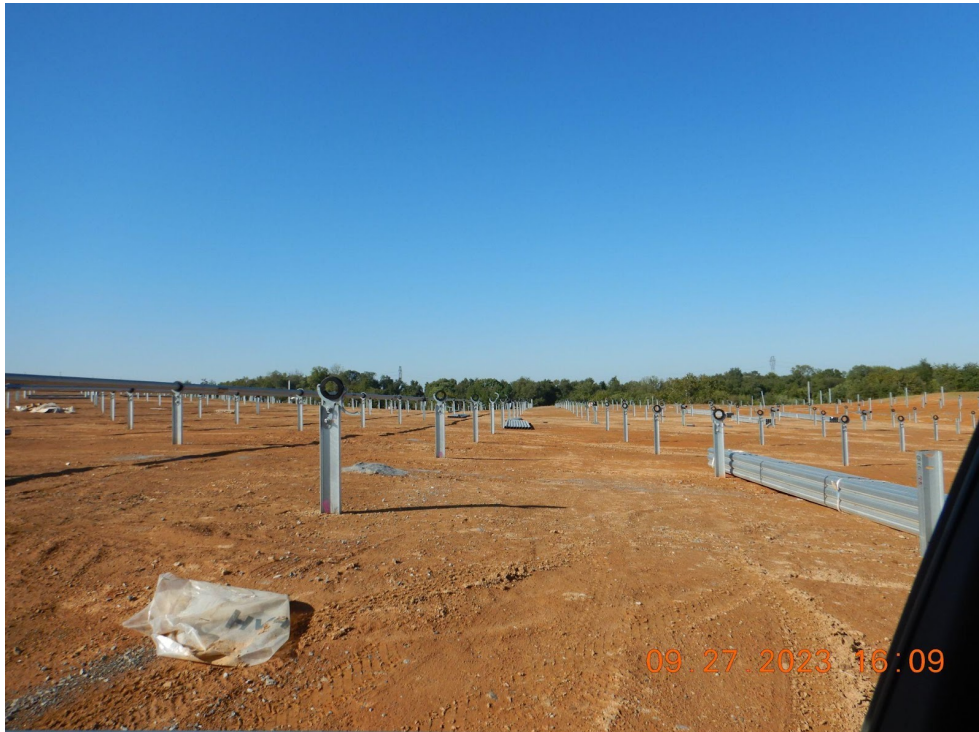
Unstabilized area of project. Temporary or permanent stabilization hasn't been started.

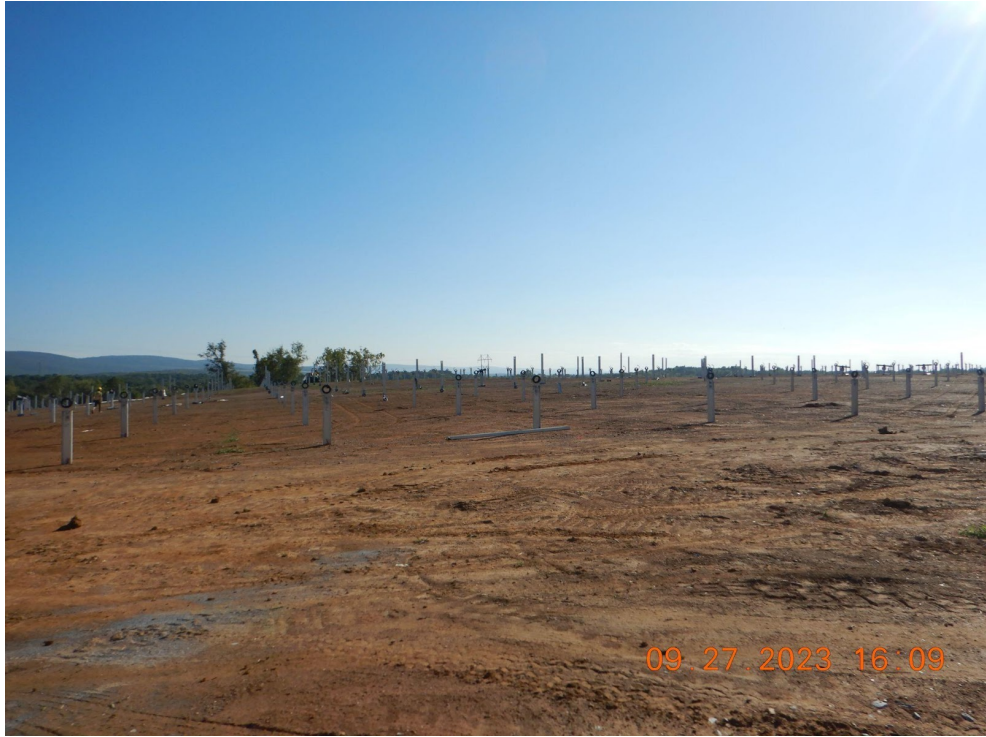
Unstabilized area of project. Temporary or permanent stabilization hasn't been started.

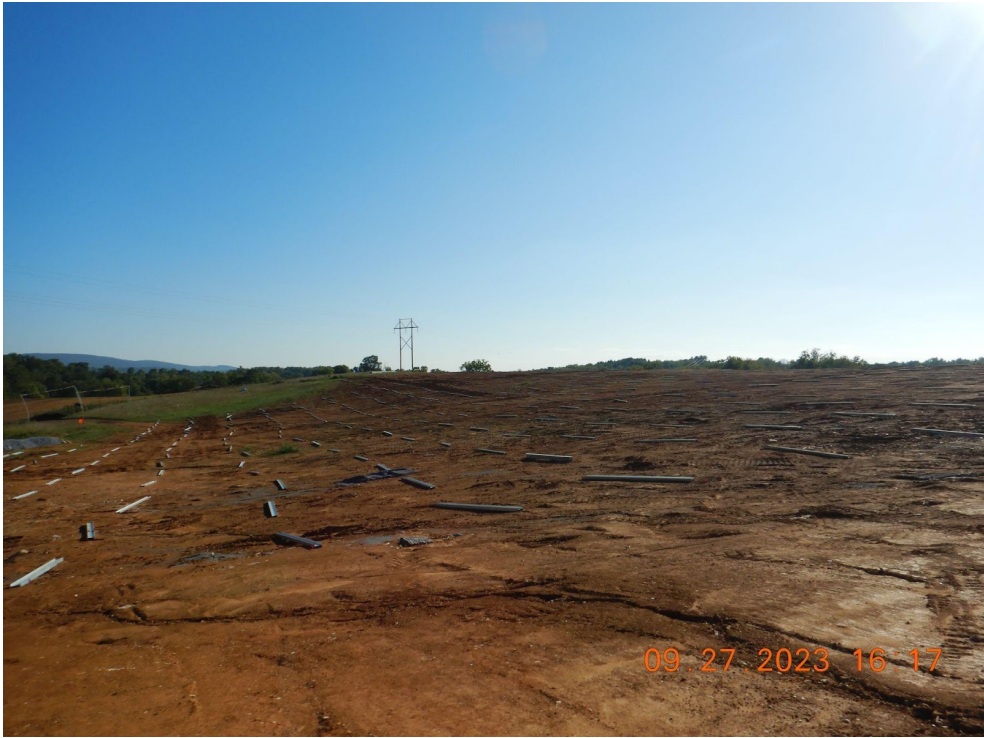
Unstabilized area of project. Temporary or permanent stabilization hasn't been started.
